Stilling Basin Abrasion Research
Principal Investigator : Leslie Hanna, Hydraulic Engineer, WRRL

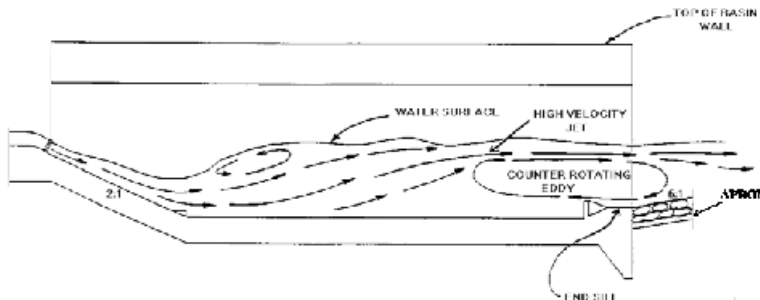
Reclamation Type II and Type III stilling basins have experienced significant abrasion damage caused by rock, gravel, and sand brought into the basins by reverse flow over the basin end sill as a result of normal operation of a hydraulic jump energy dissipation basin (figure 1). Damage occurs when material, carried into the basin, becomes trapped and turbulent flow continually moves the material about the surface causing severe damage to concrete.

Figure 1. Counter-rotating flow eddy over basin end sill and lower apron.

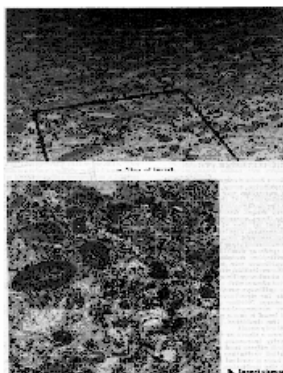
Figure 2. Typical abrasion damage.

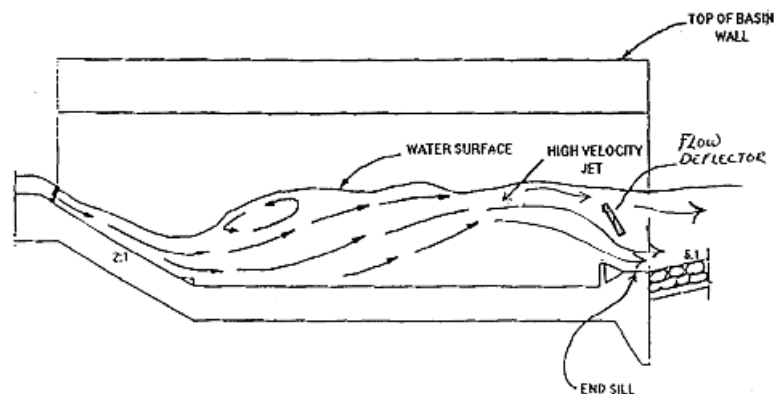
Research conducted by Reclamations's Water Resources Research Laboratory (WRRL) has demonstrated that the installation of flow deflectors can improve or eliminate the potential for moving materials into the basin, thereby minimizing damage and extending the life of the basin.

Figure 3. Desired flow pattern with deflector installed.
